# AQUATECH PARTS BULLETIN

This is an informational bulletin to help identify the Y-Strainers use on our truck mounted units.

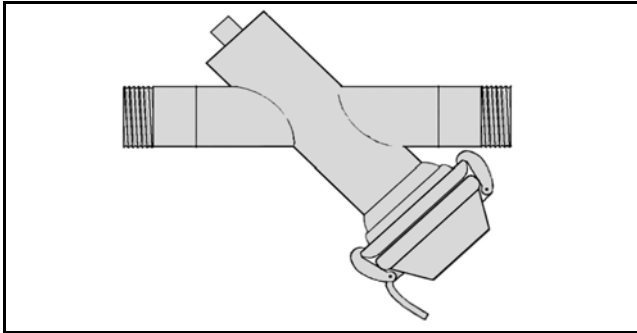
**OBSOLETE A240026**

This is the original metal Y-strainer used by Aquatech, Inc. It was found on just about all truck mounted units (C-series, B-series, SJ, and SJR) up until the mid 90s. It featured 2½" male NPT threads and a camlock cap. The assembly is obsolete and must be retrofitted by A380819 or A380820.

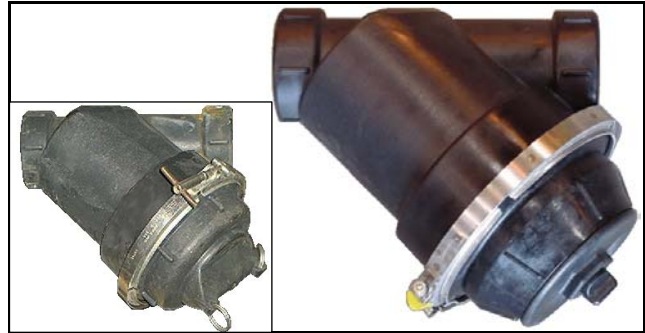
**OBSOLETE A240027 & A380806**

These 3"FNPT Y-strainer feature a stainless steel V-band clamp to hold the cap on. The earlier version of this strainer (p/n A240027 in the inset) had a T-handle nut on the clamp. The succeeding version (p/n A380806) utilized a locknut on the clamp and added a cap with a screw out outer cap to access the screen. Both of these are no longer available and are replaced by p/n A380820 below.

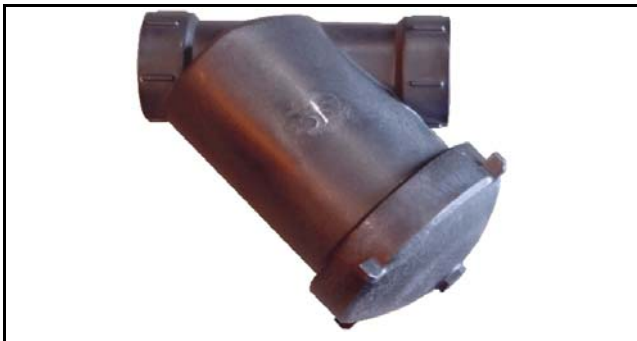
**A380819**

The A380819 replaced the A240027 in production. Initially this was a running change made by Aquatech Inc. and part number A240027 was listed in many owners manuals for this strainer. Later part number A380819 was established to help alleviate confusion over replacement components.

**Note:** To prevent damage to the cap ears for the above two Y-strainers, we suggest that spanner wrench part no. A380193 be purchased also.

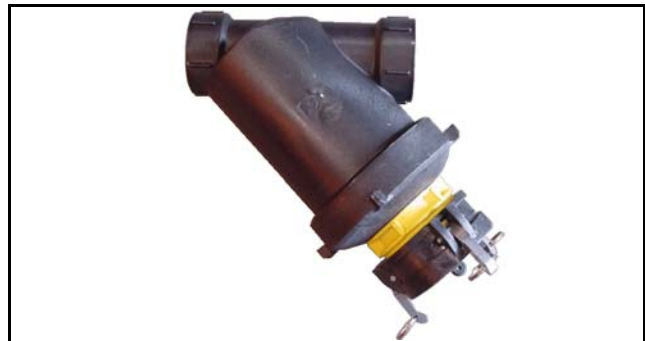
**A380820**

This is the 3"FNPT Y-Strainer used in our current production machines and is by far the best design. The camlock outer cap makes it easy to check the screen on a regular basis.
